Shorebury Garrison Conservation Area Appraisal

Southend-on-Sea: Milton Conservation Area Appraisal

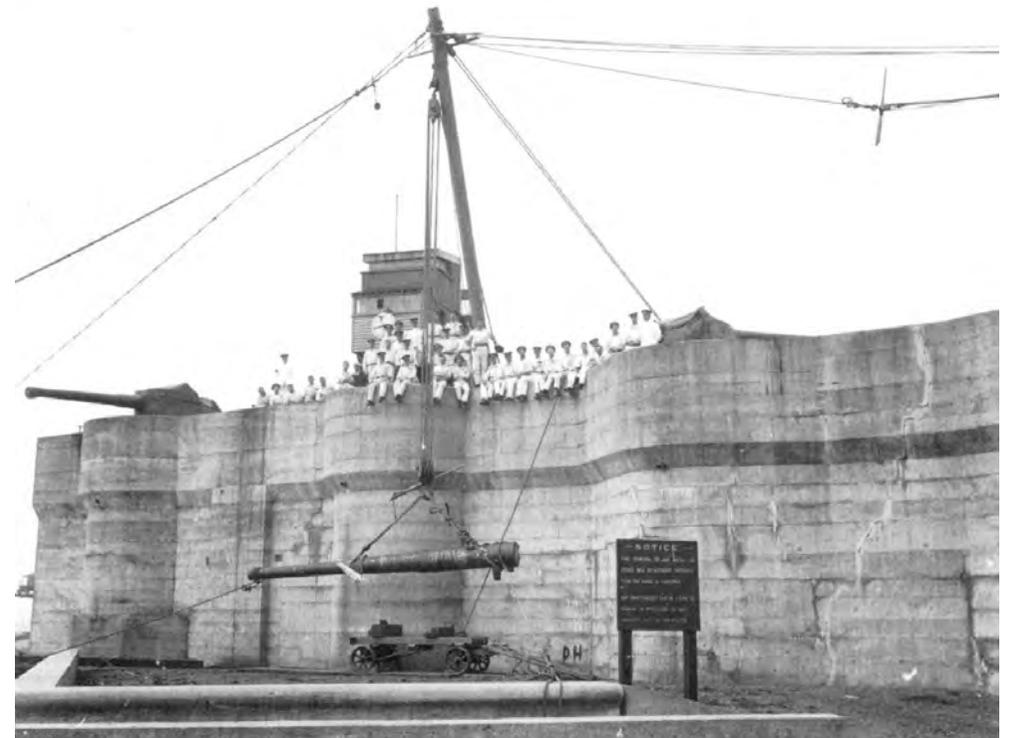
The Heavy Quick Firing Battery seen in 1914

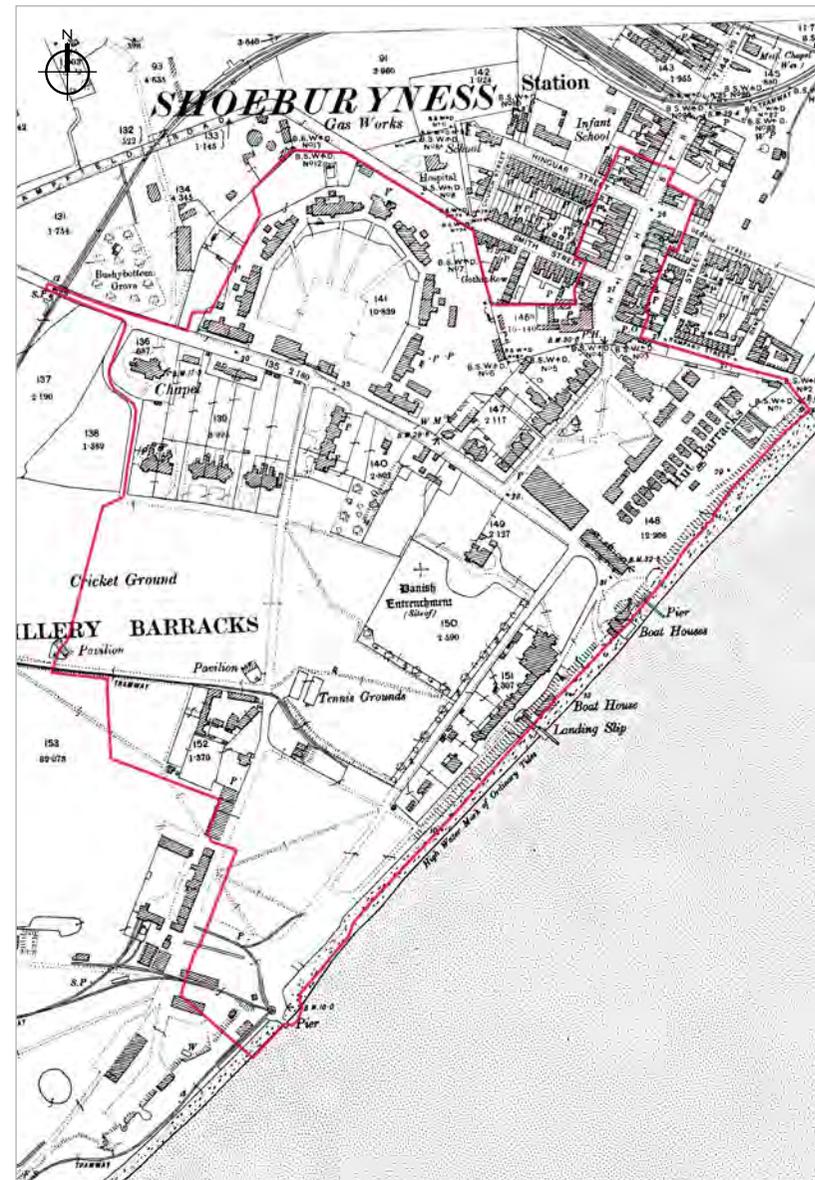
Map D: Ordnance Survey map 1895 © Crown Copyright 2019. All Rights Reserved. Licence number 100019680

4.2.20 The OS map from 1895 (Map D) shows the extent of the Garrison and nearby development by about 1895. Since the 1874 map further small buildings had been constructed to the north of the Carriage and Wagon shed and the cricket ground had gained two pavilions (the one to the south-east still survives). The development around the High Street is seen, with many more rows of terraced houses and the Hignaur Street School added. The railway extension to Shoebury is also shown on the map.

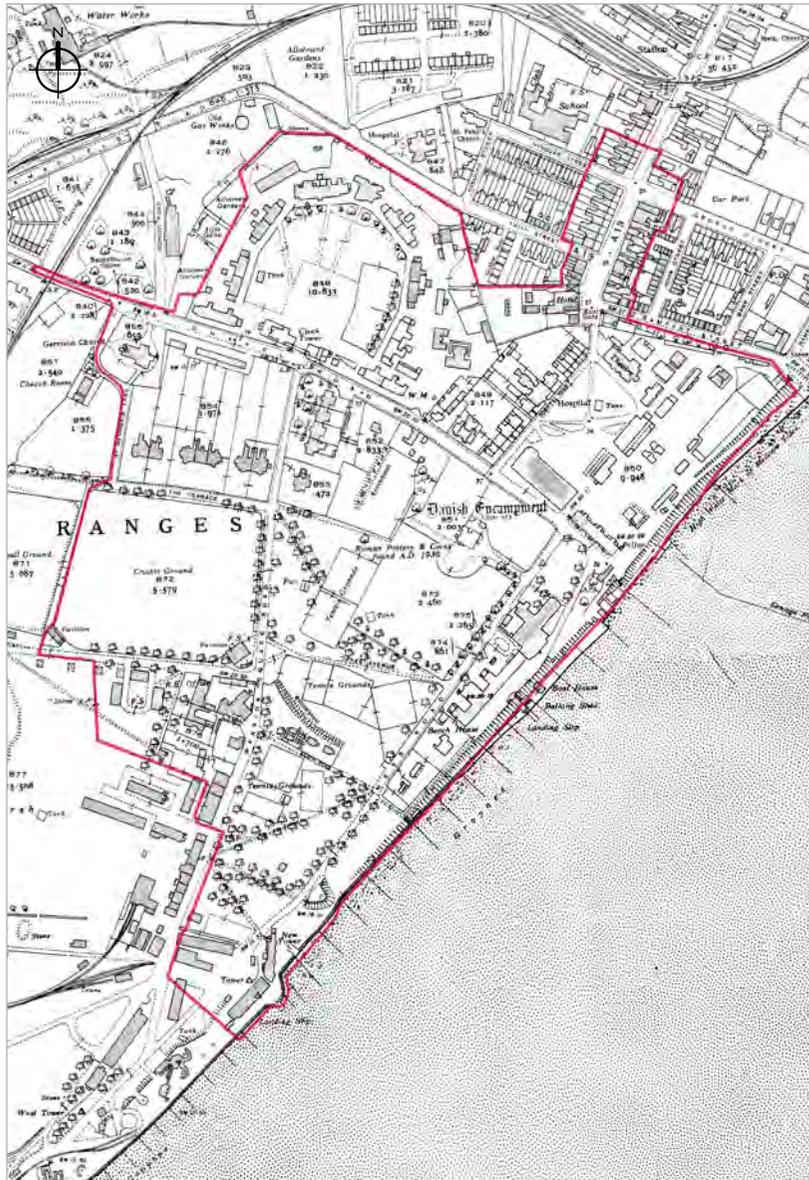
Map E: Ordnance Survey map 1939 © Crown Copyright 2019. All Rights Reserved. Licence number 100019680

4.2.24 The 1939 OS map (Map E) shows the changes to the site in the early-20th century. The Heavy Quick Fire Battery is seen at the southern end of the Conservation Area, with several other buildings to the west of that (which are no longer there today). The old hut barracks have been demolished and replaced with a series of small buildings of unknown use. The theatre (no longer extant) is also marked at the north end of Hospital Road

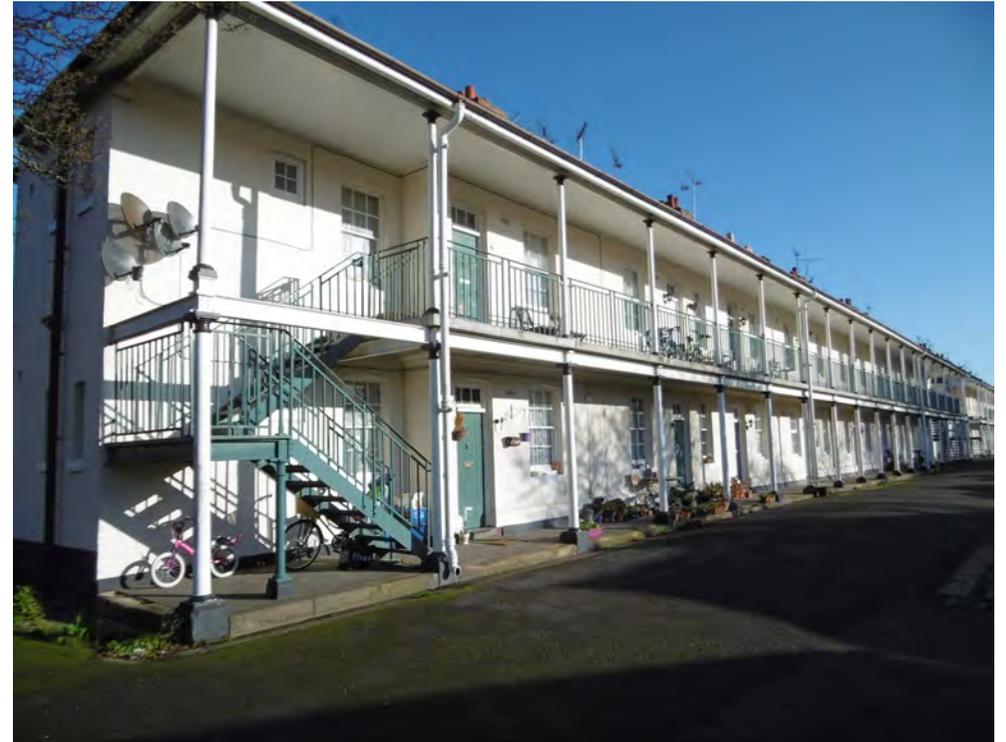
5.1.8 The **'Birdcage'** (now Ash Court and Beech Lodge, Rosewood Lane, outside the Conservation Area but Locally Listed), c.1900, built as married soldiers' quarters, without the innovation of the earlier Horseshoe, but with the same simplicity of design and detail. They comprise two blocks of two-storey buildings with a walkway at first floor, covered by a projection of the pitched roof and with simple iron columns, stairs and metal balustrade (from which the nickname derives). Each block has a symmetrical frontage with individual boarded doors to each unit and sliding sash windows with small panes.

The 'Birdcage', former married soldiers' quarters

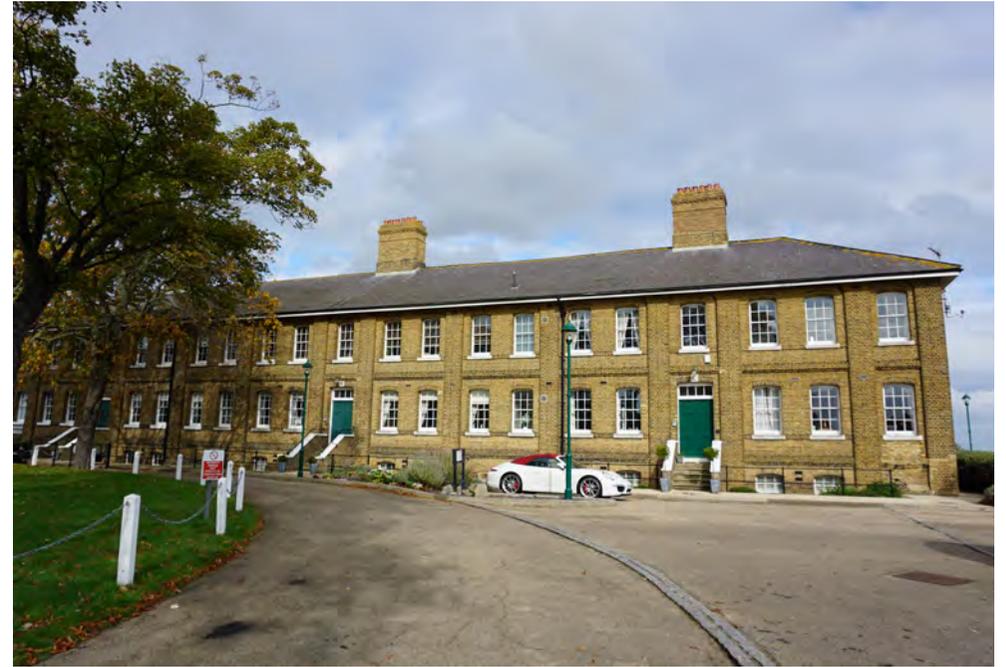
5.1.10 **Single Officer's Quarters** for the British School of Gunnery (now Gunnery House), 1871. A yellow stock brick range of 21 window range of uniform appearance. Three double doors accessed up steps and a long roofline punctuated with three large chimney stacks. To the rear are three attached ablutions towers.

Gunnery House

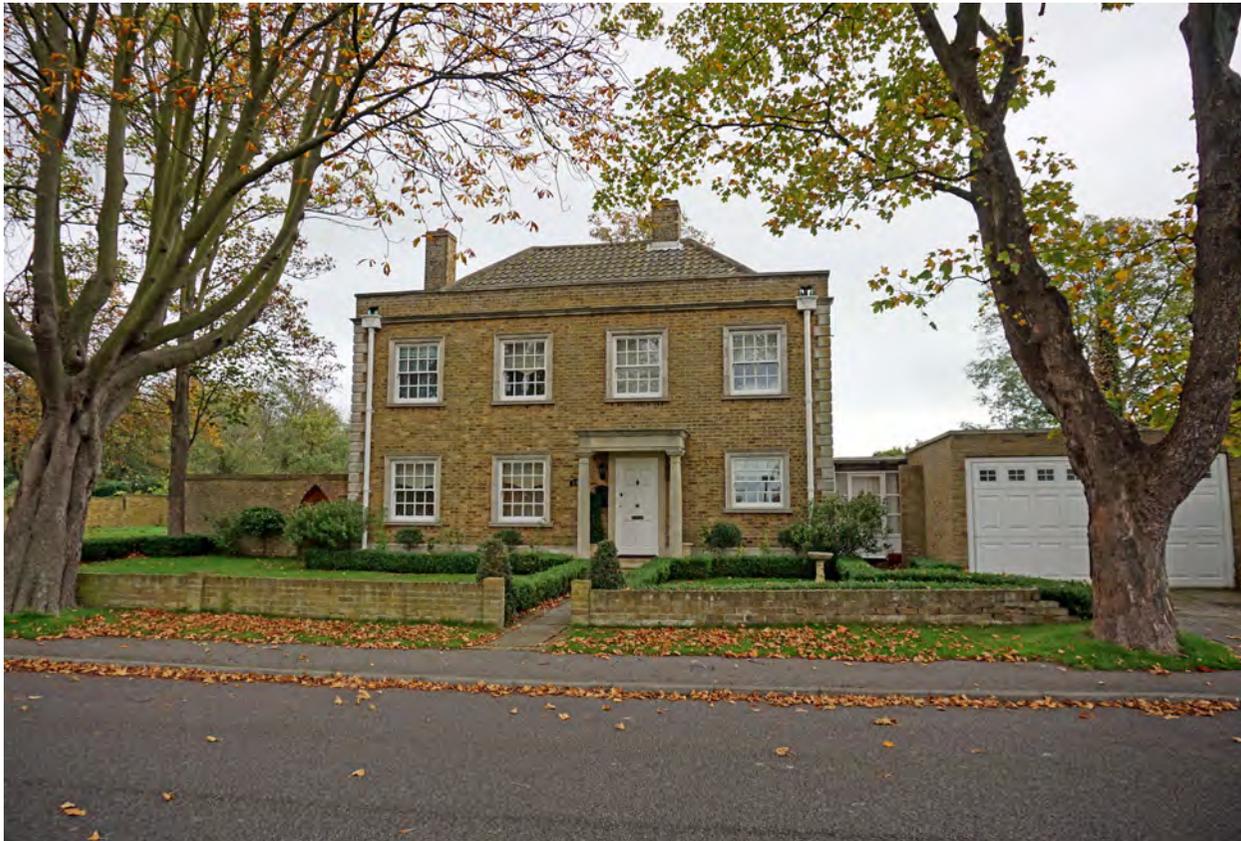
5.1.20 Five detached houses on the east side of the cricket ground were built in the mid- to late-20th century, presumably as further officers' quarters. These are neo-Georgian in style, in stock bricks with ashlar quoins, dressings and columned porches.

Mid- to late-20th century house on the east side of the cricket ground

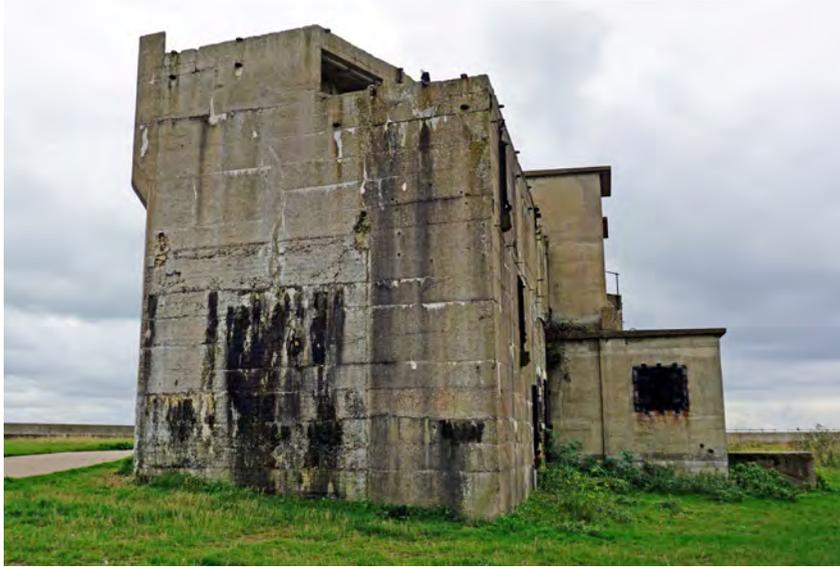
Salt and water staining, and cracked concrete to the Heavy Quick Firing Battery (some remedial work has been carried out to this structure)

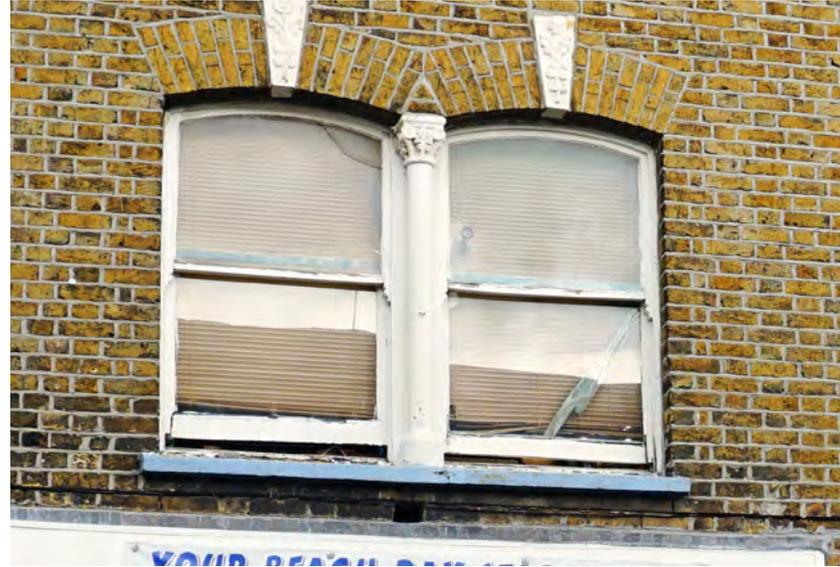
Joinery in poor decorative condition on the High Street

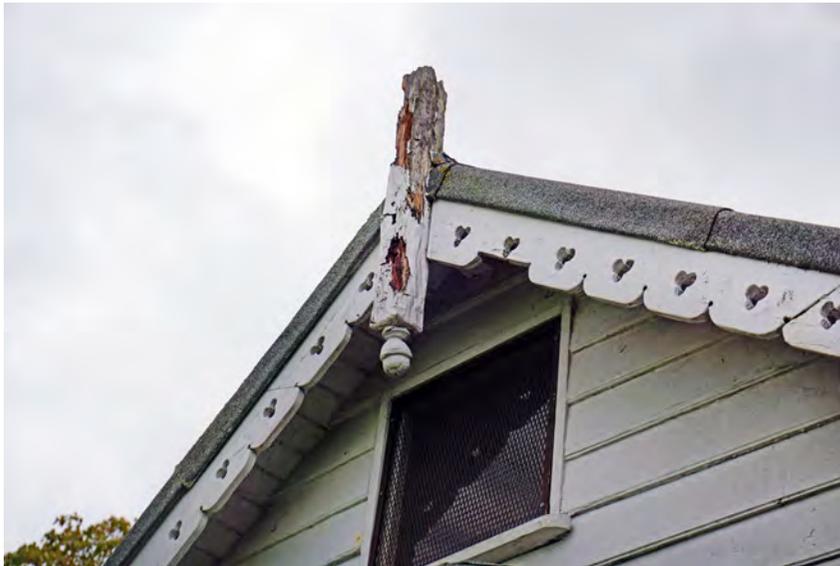
Deteriorating woodwork on the cricket pavilion

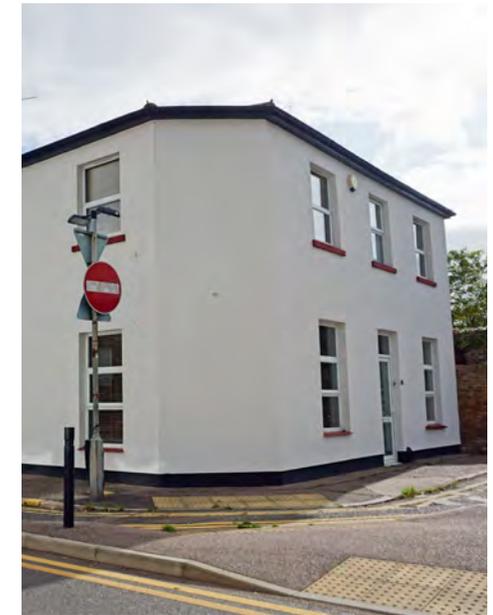
Appearance of No.2 High Street today, with door and shop window removed, render added over brickwork and timber sash windows replaced since the last Appraisal in 2004 with uPVC top hung units

6.3.15 On the High Street there has been a much greater level of inappropriate change which has eroded its character and appearance. Historic photographs, show how the character of buildings can be changed dramatically by such alterations. These changes reduce the coherency of appearance of rows of terraced houses/shops or can be detrimental to the condition of the building in the long-term. The replacement of these features with designs and materials which reflect the historic form of the building would enhance their appearance.

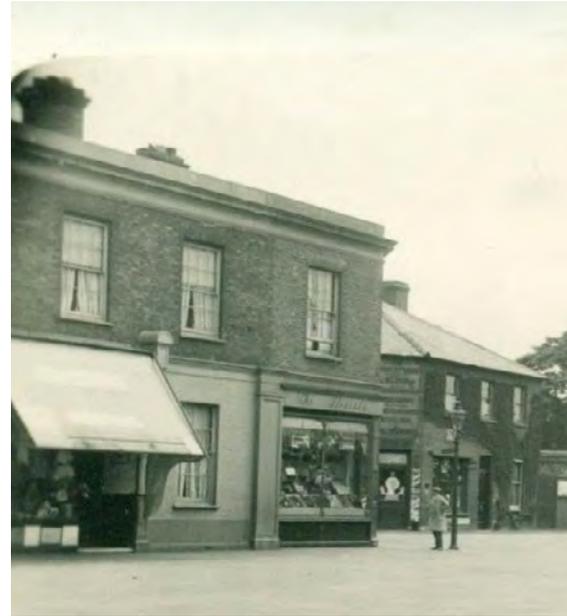
Shops on the High Street in the early-20th century, showing retractable canvas awnings, timber framed shop fronts with painted fascia boards and timber sash windows

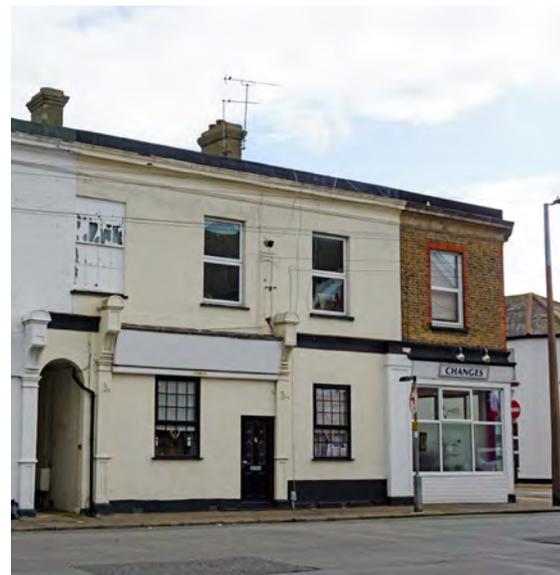
The same shops in 2019 with unsympathetic replaced shop windows and signage or shop fronts removed, and inappropriate uPVC windows

6.4.32 It is recognised that many shopkeepers and businesses wish to install security measures to protect both their premise and stock. Features should not detract from the vibrancy of the street scene. Roller shutters, for example, can appear very off-putting. Alternative options which cause less harm would help to enhance the street scene, such as shatterproof, toughened laminated glass, internal shutters and grilles or decorative external grilles. Grilles and shutters should only cover the glazed elements of the shop front and the shutter box should not protrude from the fascia or beyond other architectural features.

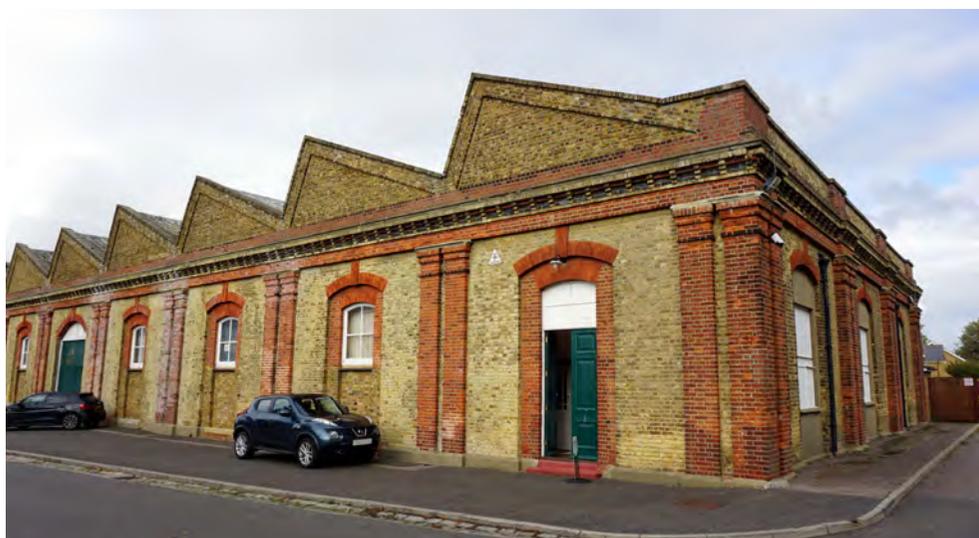
See list description for more details. 1859, early example of free-span north light roof construction. Stock brick with red and pale yellow brick detailing, including pilasters. Timber sash windows. Three door openings on south elevation, east and west openings with timber panelled double doors, central opening with boarding painted green, which would benefit with replacement with a replica door. All elevations prominent, particularly the interesting rooflight on north and south elevations. Important views northwards from Mess Road, open spaces and Chapel Road. Some granite setts evident to Chapel Road gutter. Now in use as outlet shops and a warehouse.

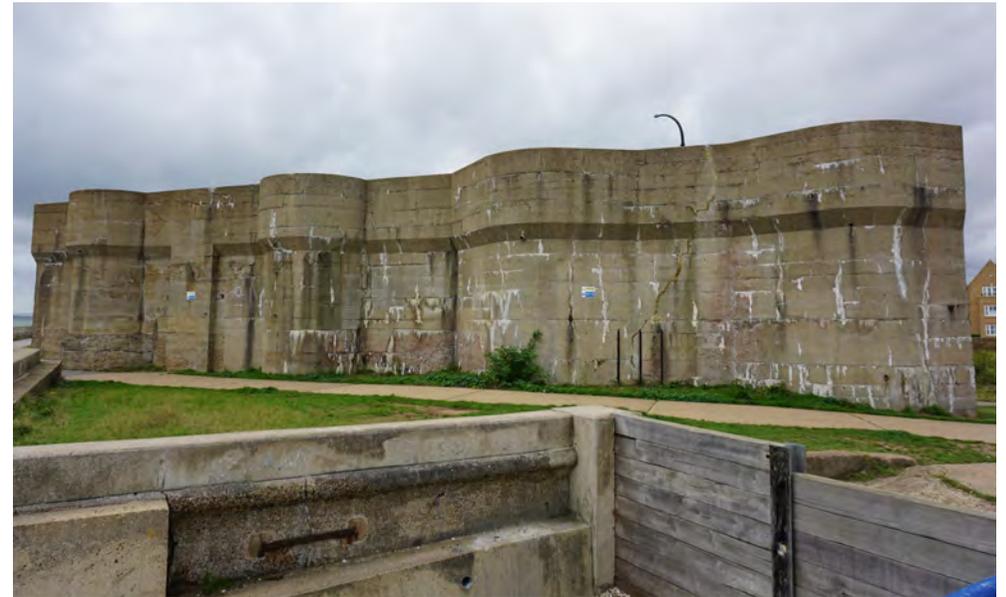
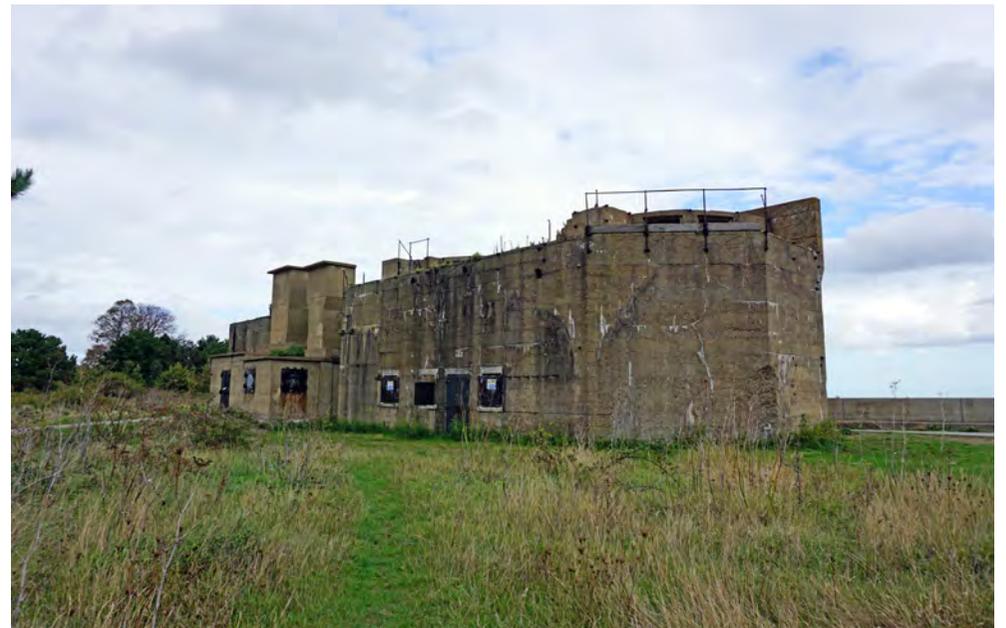
See list description for more details. c.1898, prominent position and monolithic structure make this an important military landmark on the seawall. Important to the history of the Garrison and should be preserved. Concrete construction with four semi-circular bastions on the seaward side. Only a few openings, now boarded. Stone lintels with the word 'store' carved open one door. Archaeological evidence of other military features nearby, such as four circles in the ground to the south where four drill gun pits were located. Condition could be improved.

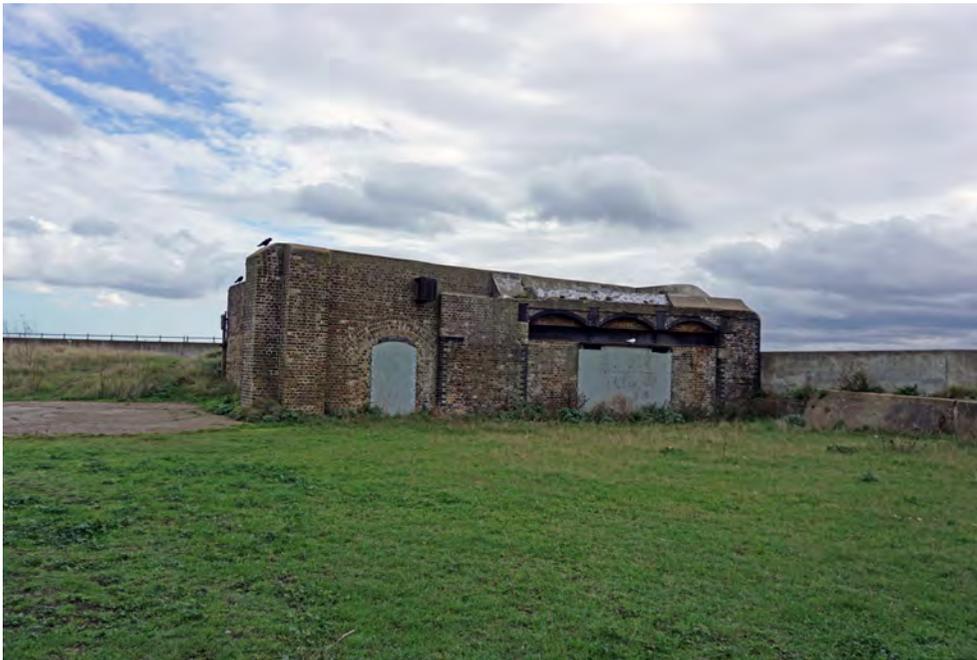
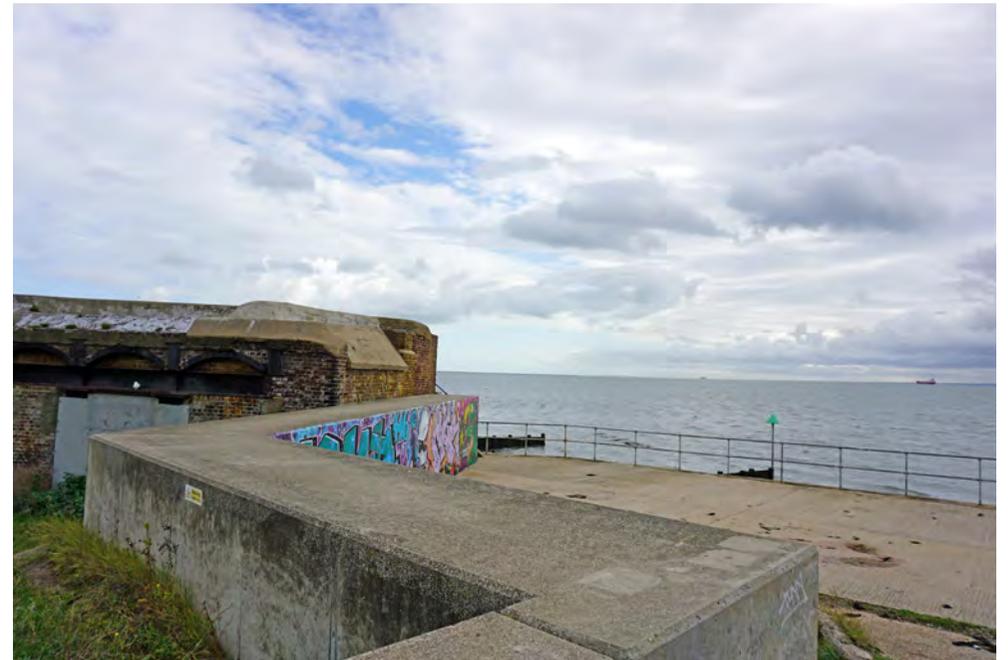
See list description for more details. Both structures built 1872-3, the battery was remodelled c.1890. Important to the history of the Garrison and should be preserved. Together, the pier and battery are prominent military structures on the seawall. Brick, with various openings now boarded or fenced off. Concrete wall enclosing concreted pier area. Condition could be improved.

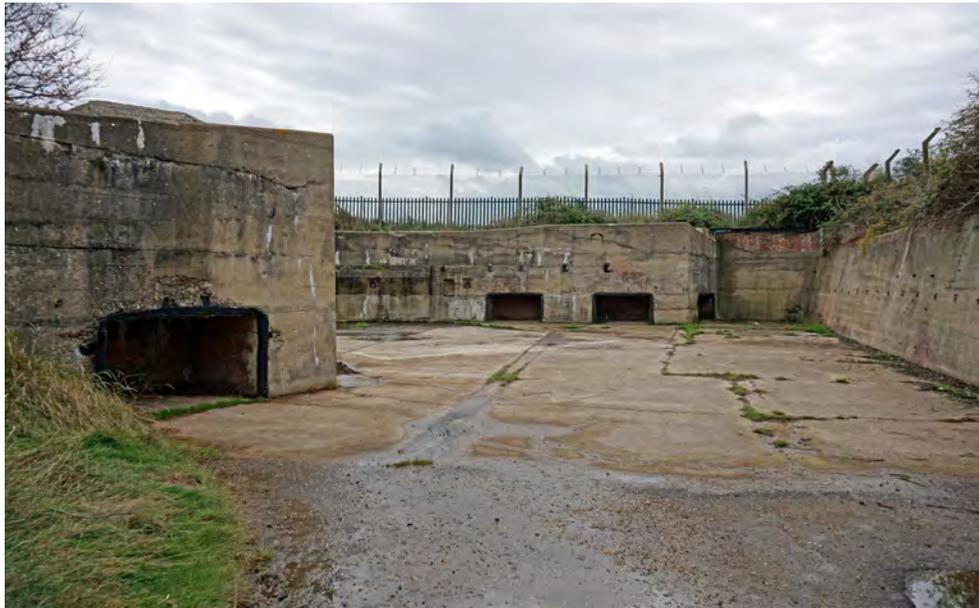
Sunken area enclosed with concrete walls with low openings in the walls, with metal door frames (doors no longer exist). Important to the history of the Garrison and should be preserved. Condition could be improved.
